**Lake Lemon Lake Enhancement Project  
Biotechnical Shoreline Stabilization Project**

**Draft Design Report**

**Lake Lemon Conservancy District**

**June, 1997**

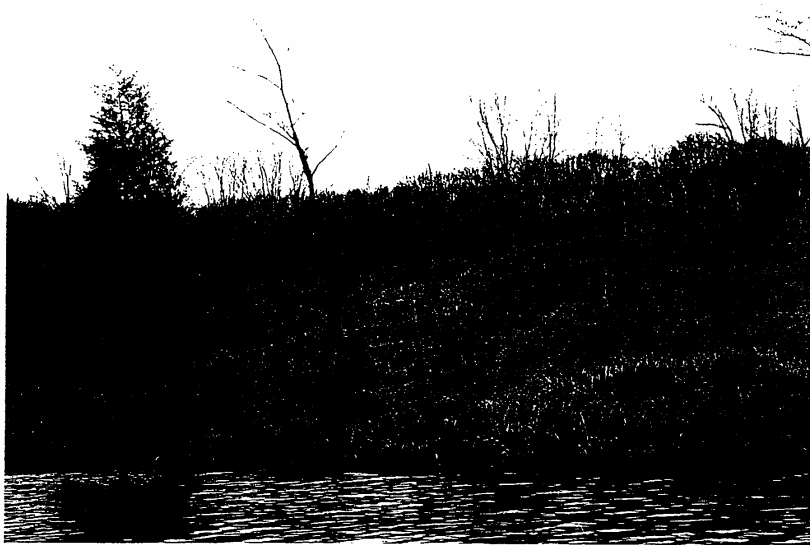
Site 1B, Photographed 4/18/97

At Site 1B, a scarp about 6 inches high was observed bounding an area of about 60 feet by 60 feet, as shown in a site photo in the Appendix. The scarp appeared to be old and shallow, and was covered by grass. The area bounded by the scarp was hummocky, and small leaning trees were observed on the slope. However, a mature located near the toe of the slope was not leaning, which is suggestive of a possible relatively shallow translational slope failure, rather than a deep seated rotational failure. However, the depth of failure plane can not be determined visually. Slope failures often occur due to undercutting of the toe; however, within the area bounded by the scarp, the undercutting at the toe was only about 1 foot above the water level at the time of the site visit. We understand Commonwealth Biomonitoring has observed animal burrows in this area, which may have furthered erosion under the bank.

At Site 1B, there is a risk that slope movement in upland slough area could resume, particularly in response to seasonal changes in rainfall and groundwater conditions. To provide detailed recommendations regarding mitigation of potential movement in this area, ETS would need to perform soil borings to identify the depth of the failure plane and obtain information regarding soil properties. We would then perform slope stability analyses, modeling existing and proposed slope conditions with a range of anticipated water conditions. Although we cannot make a determination regarding appropriate mitigation measures without further study, it is likely that a perimeter drainage trench ("french drain") along the scarp, discharging to the lake, could be effective.

In general, for the ten subject sites, we anticipate adequate erosion protection for the design wave conditions can be achieved with riprap or gabion revetments, except at sites 1B and 3B. For site 1B, where there is evidence of upland sloughing, additional measures such as drainage may be necessary to reduce the risk of continued slope movement. Additional geotechnical exploration would be necessary to develop detailed recommendations for remedial measures at site 1B. For site 3B, protection of the area of the large leaning tree is not practical without placement of fill in the lake, which we understand is not feasible based on permitting considerations. Therefore, a "do nothing" alternative in the immediate area of the tree may be the most practical alternative. Over time, continued erosion is likely to cause the tree to fall, at which time the area may be graded and slope protection installed.

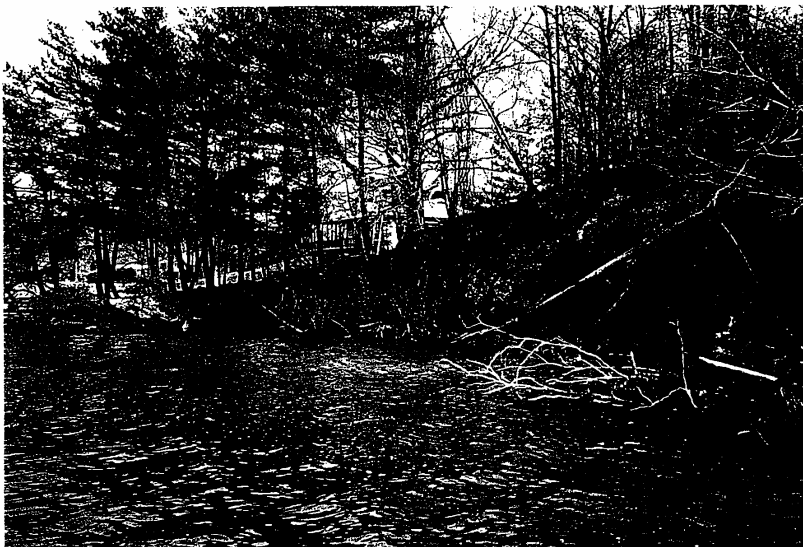
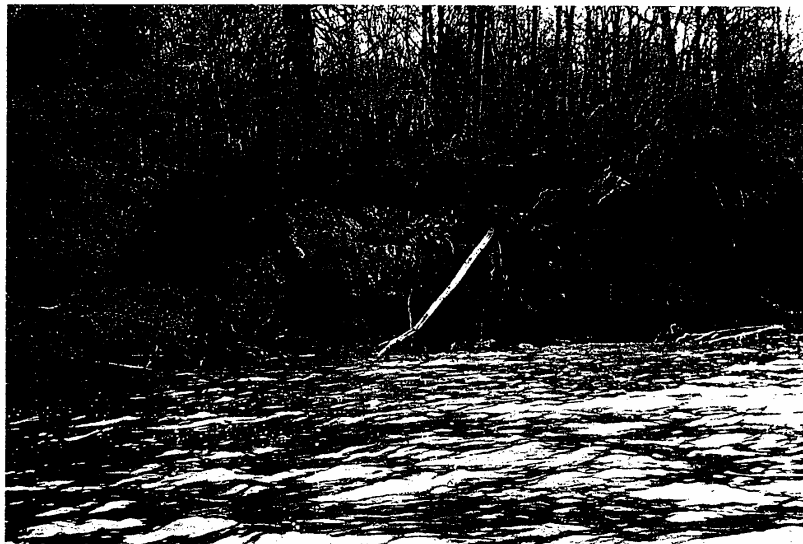
Site 3A, Photographed 4/18/97

Biomonitoring, Inc., we understand the landowner previously placed a layer of at the toe of slope at Site 3A, but the riprap failed, possibly due to insufficient height or weight to resist the wave energy. Following the failure of riprap, the slope was undermined and collapsed. The slope is nearly vertical and was visually estimated to be as high as about 12 feet above normal water level. The vertical slope failure plane shows signs of continuous caving and erosion. Stabilization of this slope is necessary to prevent further sloughing.

riprap or gabion revetments, we recommend the slopes be cut to not steeper than 2H:1V. At some sites, particularly site 3A, extensive cut will be necessary to achieve the recommended maximum slope of 2H:1V, and land acquisition may be necessary. However, potentially technically feasible alternatives such as gabion breakwaters or gabion retaining walls would require launching gabions from a barge, and would likely be more costly, based on our discussions with Commonwealth Biomonitoring.

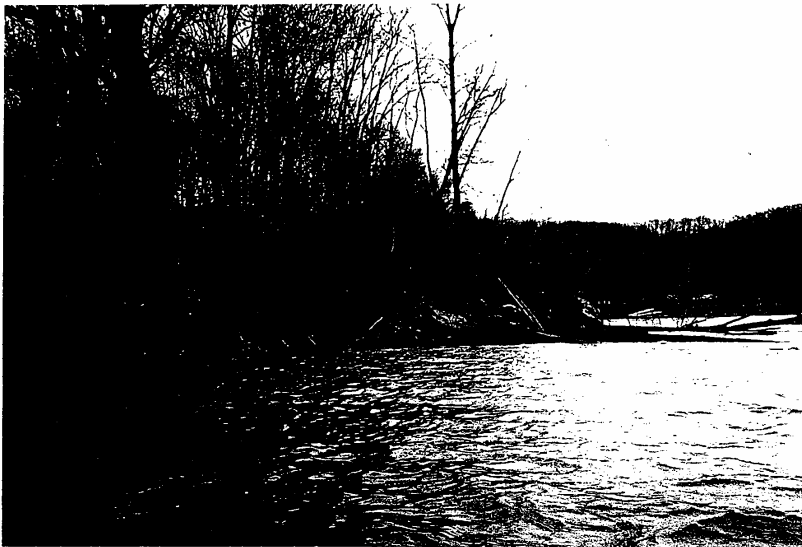
Site 3B, Photographed 4/18/97

A large tree was observed leaning toward the lake at Site 3B (see site photo in the Appendix). Based on the information provided by Mr. Steve Chafin, this large tree is frequently used as perch by the resident and migratory bald eagles at Lake Lemon, and the tree should not be removed during slope protection activities.

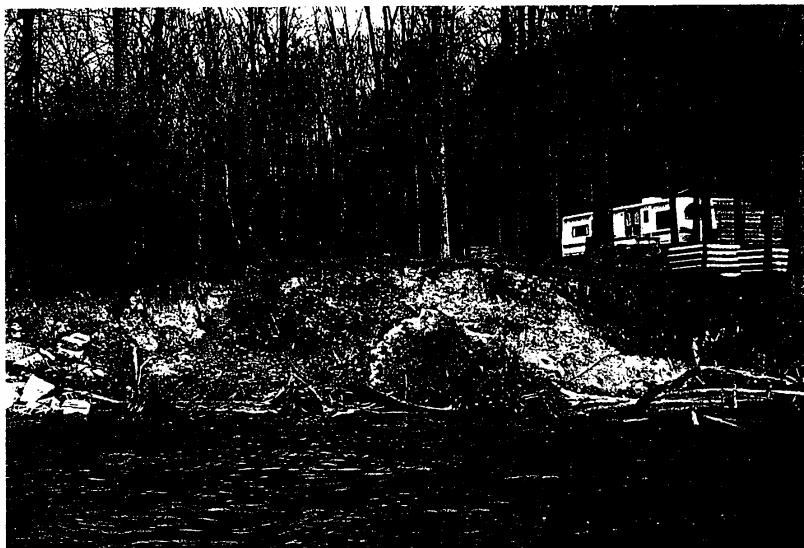
Site 3C, Photographed 4/18/97

3C	Nearly Vertical	about 4H : 1V	7	Clayey Silt to Silt	Not Observed
